LPST\_ \_IN\_20151130\_ Investigation Report  
**Texas Commission on Environmental Quality**  
**Investigation Report**

**Regulated Entity Name: ALL STAR SERVICES**

<b>Investigation #</b> 1295232	<b>Incident Numbers</b>
<b>Investigator:</b> ROBERT GILLEY	<b>Site Classification</b> UNDERGROUND STORAGE TANK - REGISTRATION
<b>Conducted:</b> 11/30/2015 -- 12/08/2015	<b>NAIC Code:</b> 811111
<b>Program(s):</b> PETROLEUM STORAGE TANK REGISTRATION	<b>SIC Code:</b> 7538
<b>Investigation Type:</b> Compliance Investigation	<b>Location:</b> 1015 W Main St, Arlington, TX
<b>Additional ID(s):</b> 43864	
<b>Address:</b> 1015 W MAIN ST, ARLINGTON, TX , 76013	<b>Local Unit:</b> REGION 04 - DFW METROPLEX
	<b>Activity Type(s):</b> LPSTWOSPL - Investigation at LPST site without sampling

## PHOTOGRAPHIC DOCUMENTATION

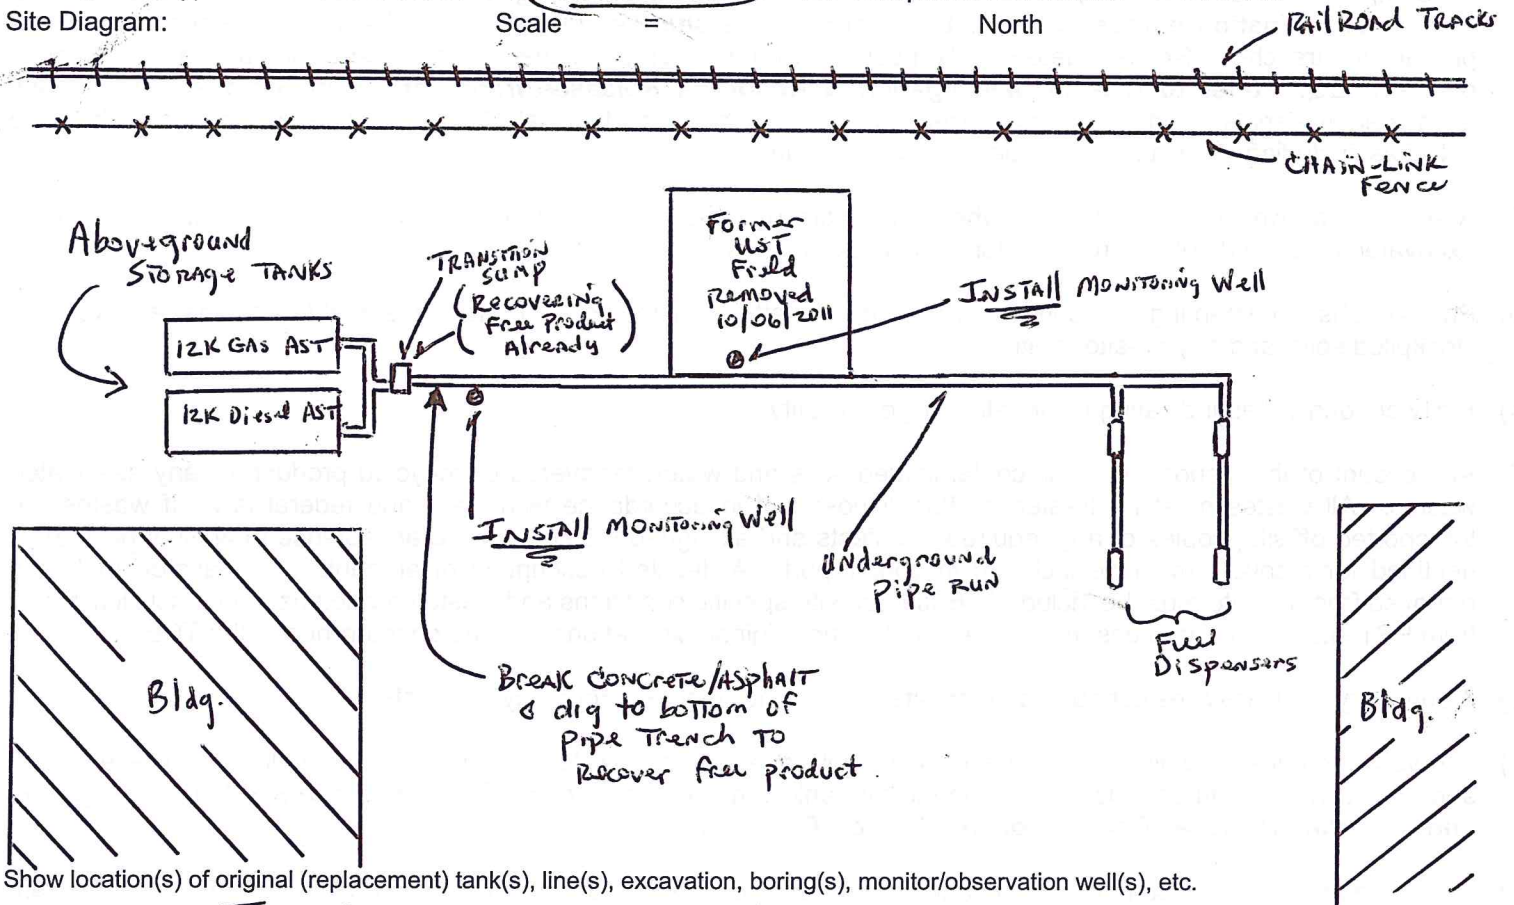
Site Diagram:

Show location(s) of original (replacement) tank(s), line(s), excavation, boring(s), monitor/observation well(s), etc.

Directives: INSTALL TWO MONITORING wells AS MARKED AT A minimum  
to check for further free product. In Addition, break through  
the surface and dig down to the bottom of the pipe trench to  
further recover ANY free product present in the trench, continue  
to recover free product as it flows INTO the transition sump.

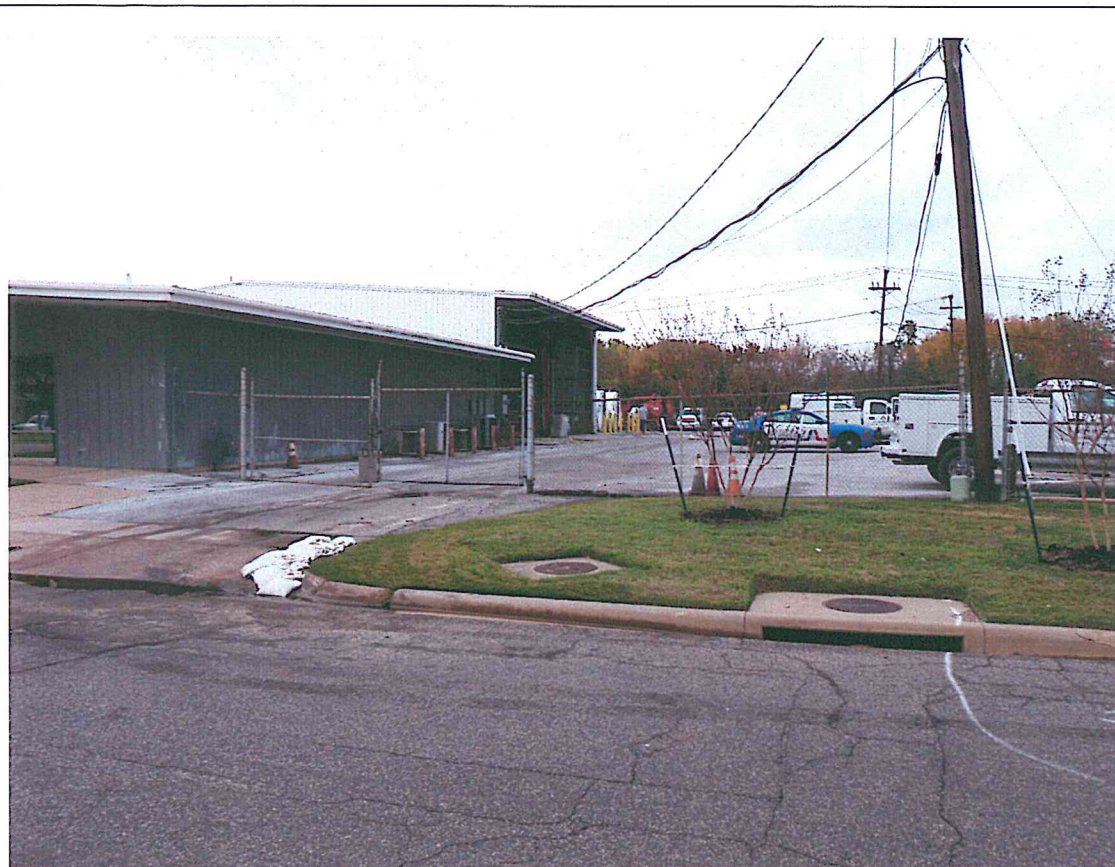
Photograph: 1

View looking north towards the AST system on the City of Arlington's facility.

Diesel ran across the parking lot and entered the storm drain pictured here.

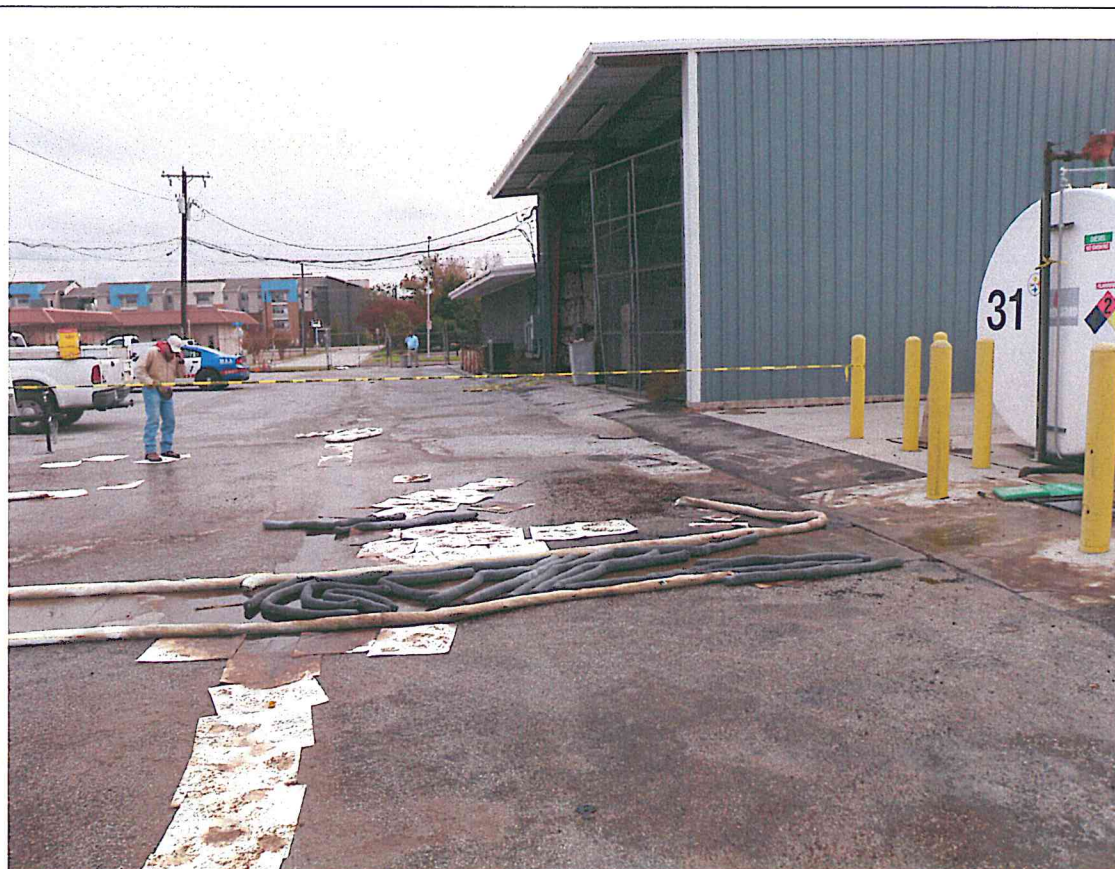
Photograph: 2

View of the area in the parking lot where the diesel seeped up through the asphalt.

On November 30, 2015, Lonnie Gilley with the TCEQ DFW Region Office was on-site to oversee the remediation efforts and met with Bill Brown with the City of Arlington. The TCEQ directed the city to break through the asphalt/concrete at the source of the piping release and begin product recovery from the pipechase. Subsequently, the city's contractor W Two Plus broke through the paving. Based upon observations after excavating into the piping run, the pea gravel backfill around the fuel lines was noted to be full of fuel that surfaced due to the recent record rainfall. Product recovery was initiated from the excavation via vacuum truck. Tim Herman with W Two Plus stated that his testing staff had determined the location of the piping leak to be in the diesel line between the AST and the transition sump. As a result, the product lines for both the diesel and gasoline ASTs would be re-routed to enter through the top of the transition sump to bypass the leaking section of product line.

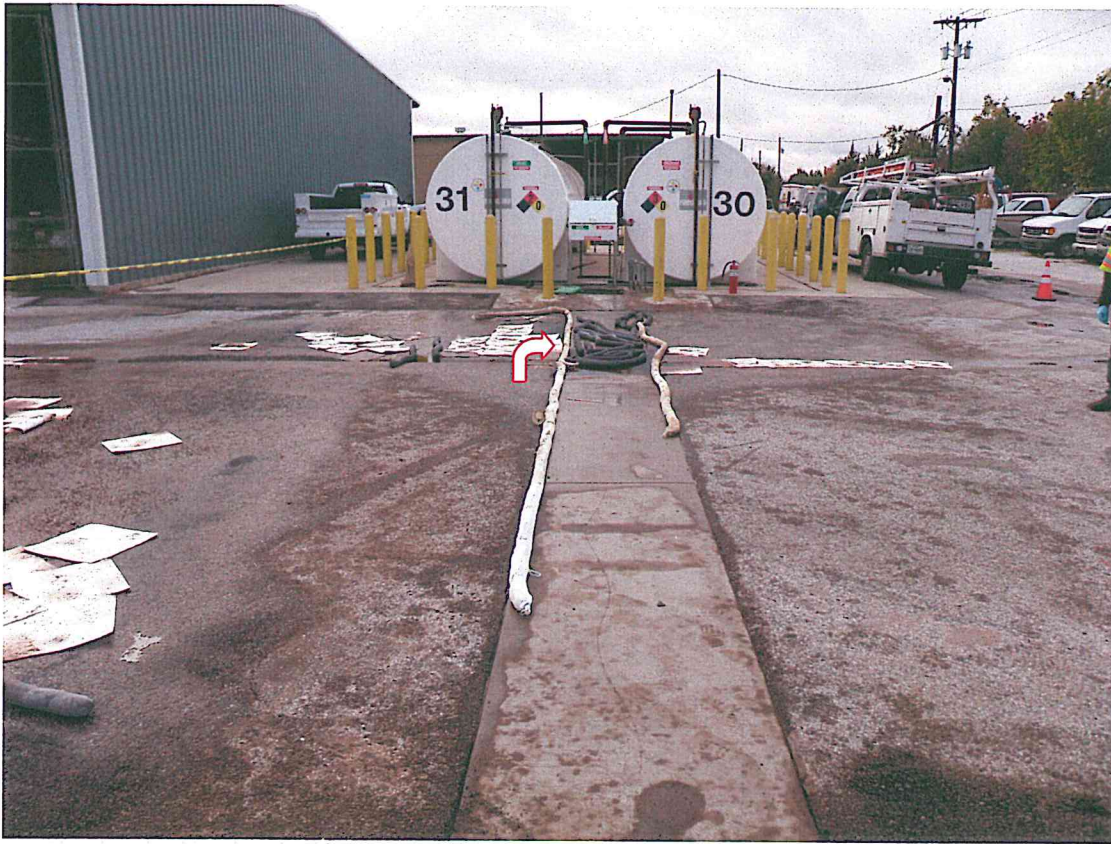
Photograph: 3

Photo of the two ASTs and the underground product pipechase. The pipechase is surfaced with concrete.

The arrow marks the diesel seepage location.

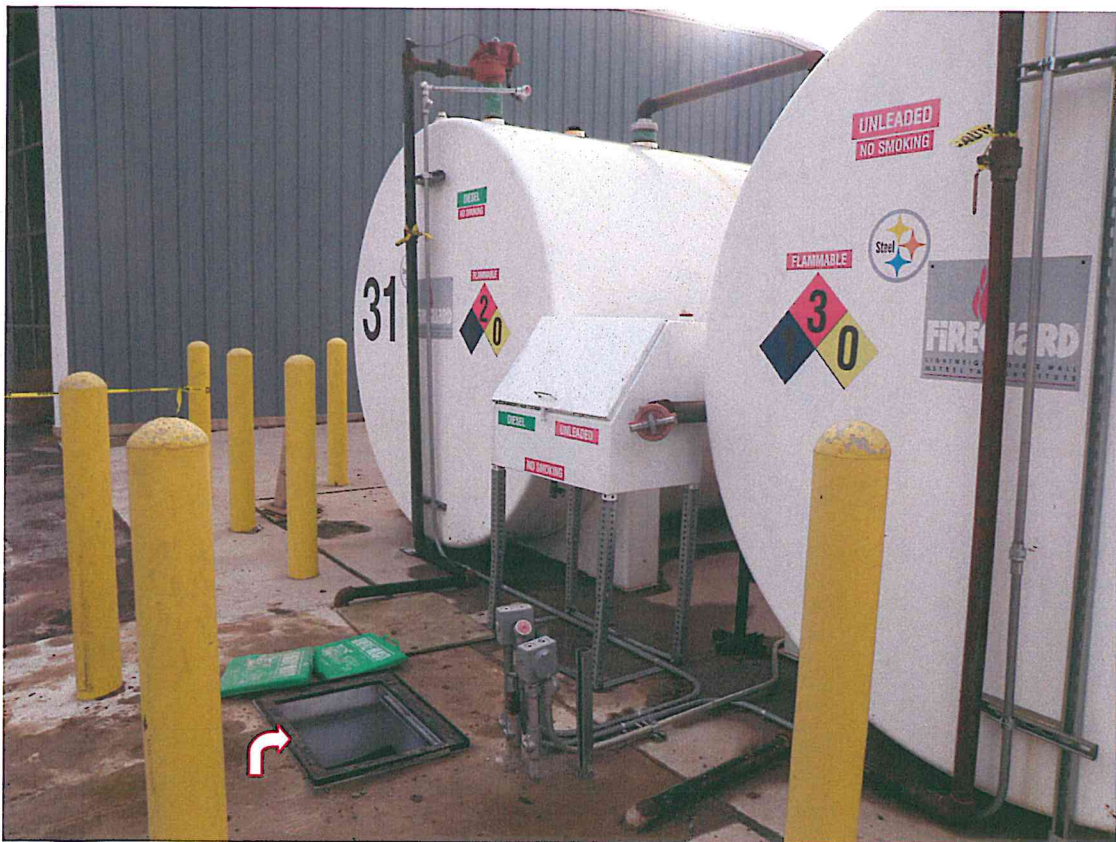
Photograph: 4

The product piping enters the ground from the ASTs and passes through a transition sump (marked by the arrow).

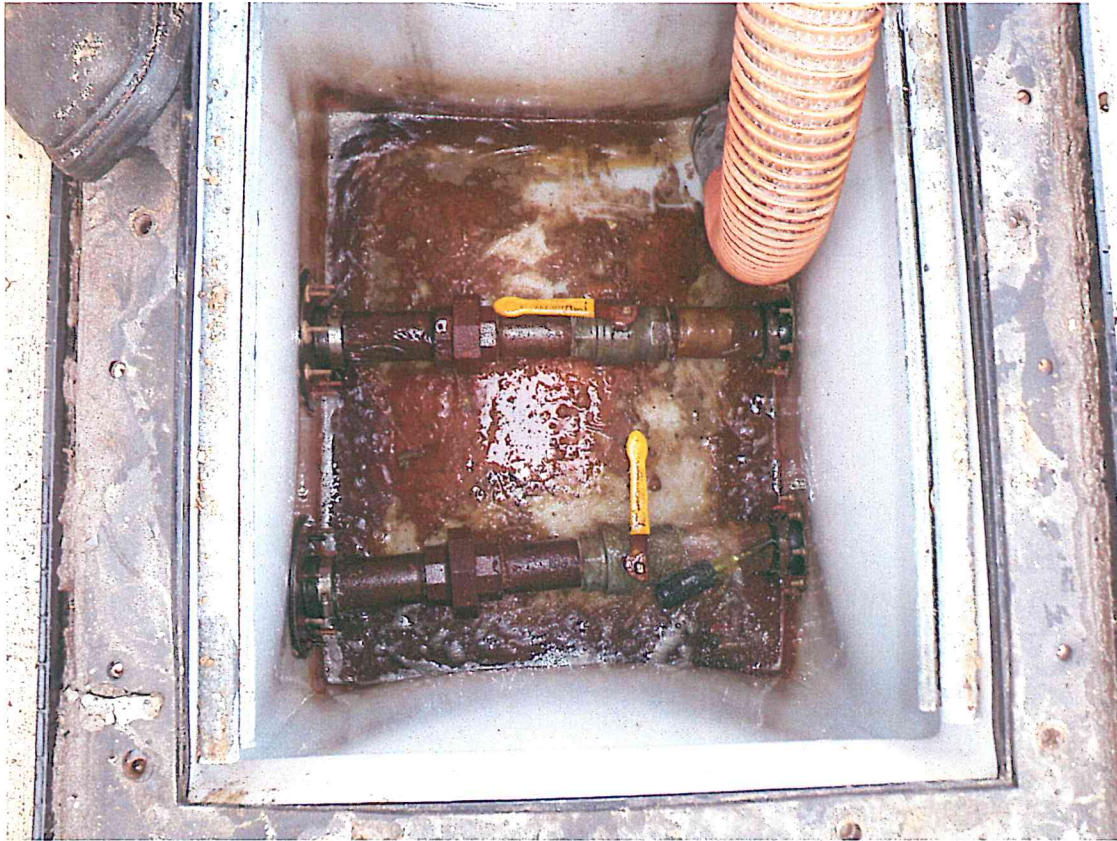
Photograph: 5

Releasing the penetration boot seal in the transition sump resulted in diesel fuel flowing into the sump; this confirmed that the pipechase was full of fuel.

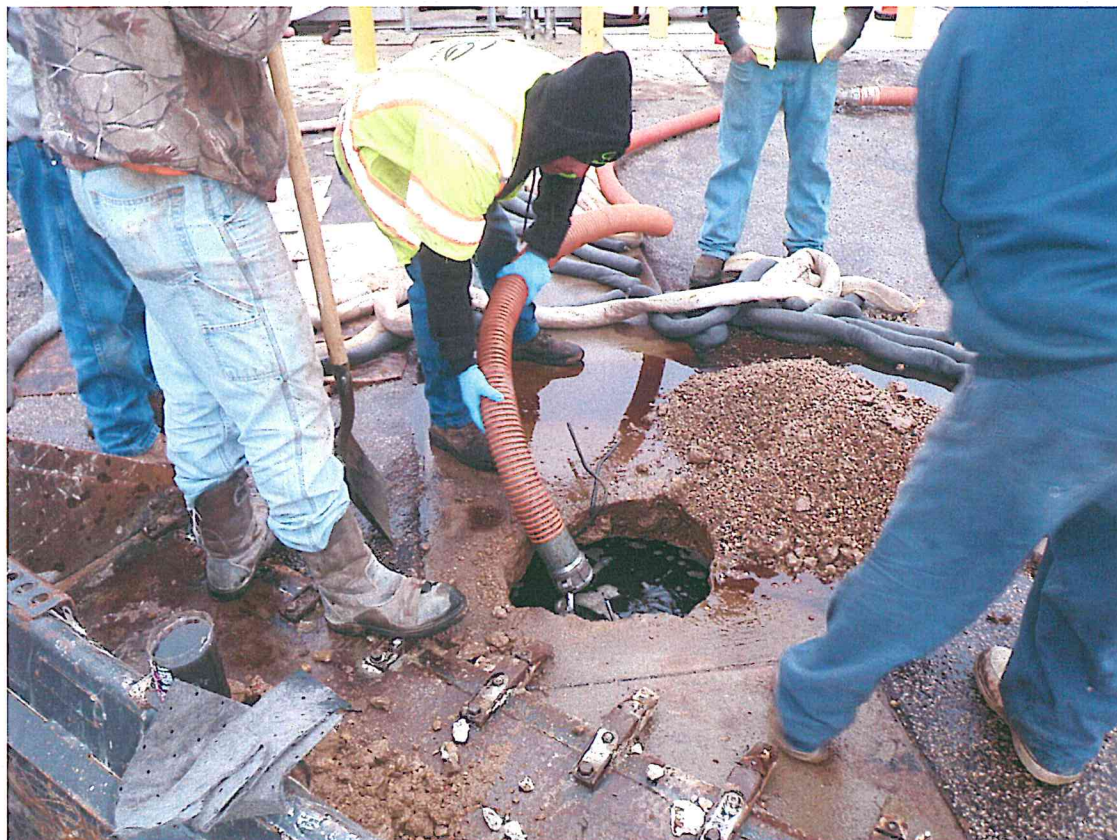
Photograph: 6

The contractor broke through the surface paving to access the pipechase backfill as directed by the TCEQ.

Pipechase was observed to be full of diesel fuel and product recovery was initiated via vacuum truck.

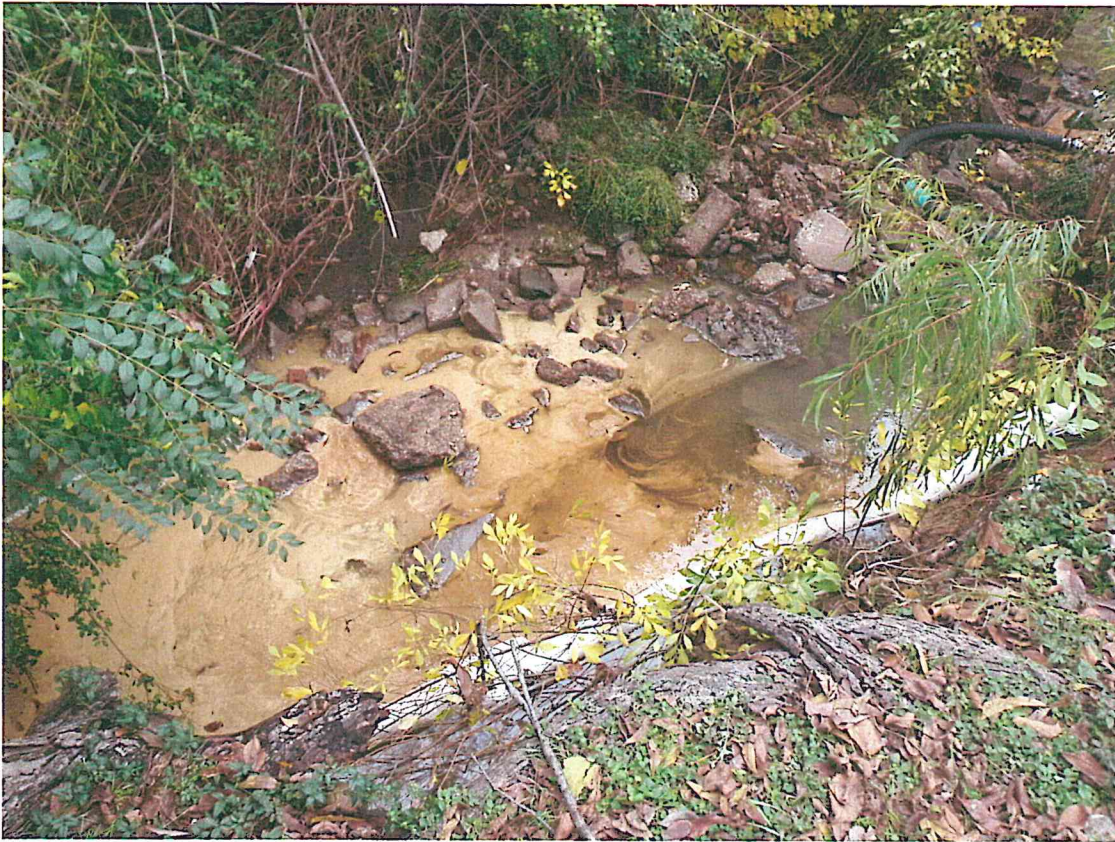
Photograph: 7

The storm drainage system empties into a tributary known as Timber Brook.

Diesel impact to the tributary was clearly noticeable with a strong diesel odor.

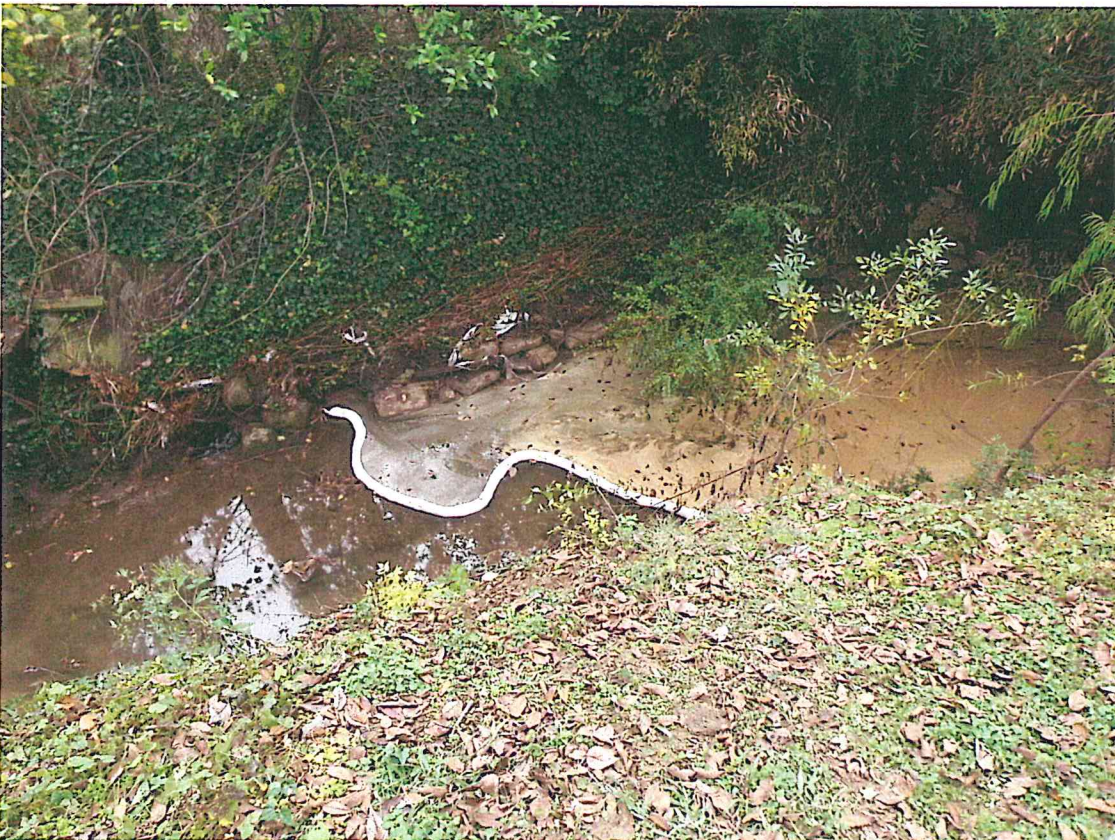
Photograph: 8

Photo showing absorbent boom placed into the tributary.

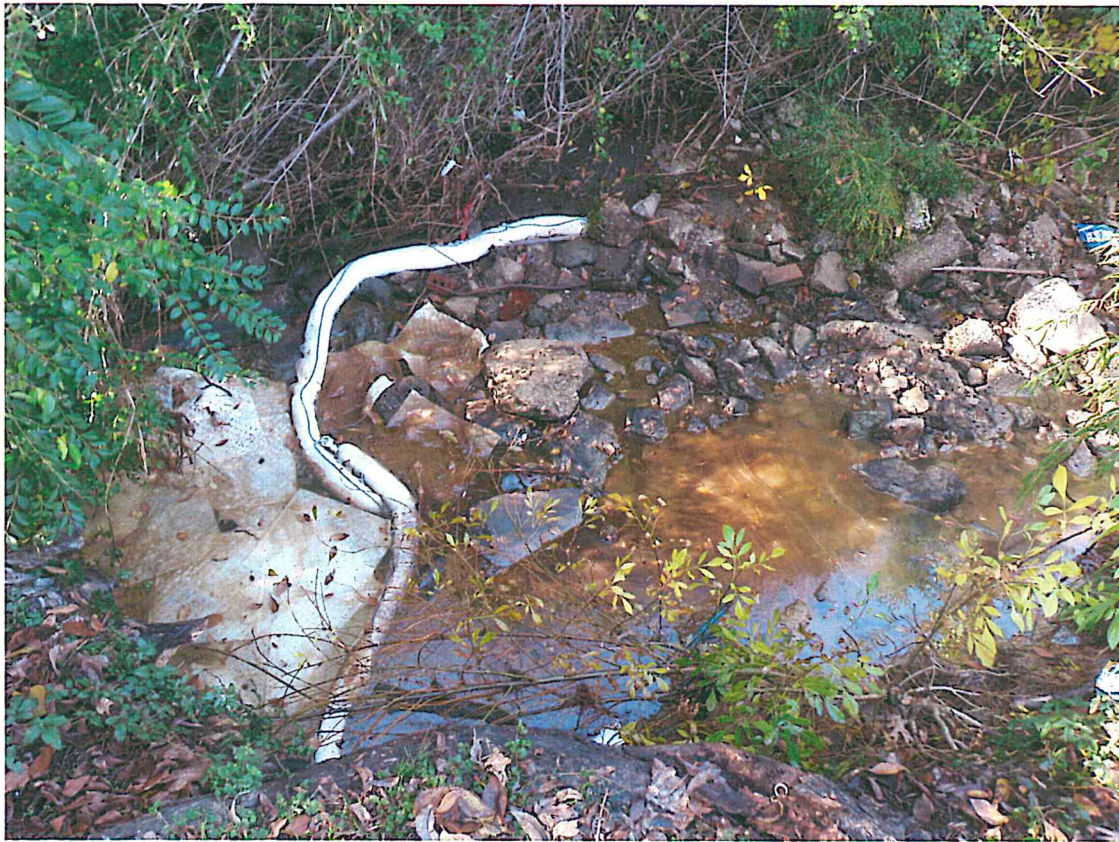
Photograph: 9

Absorbent pads and booms were placed in intervals along the waterway to allow for product recovery.

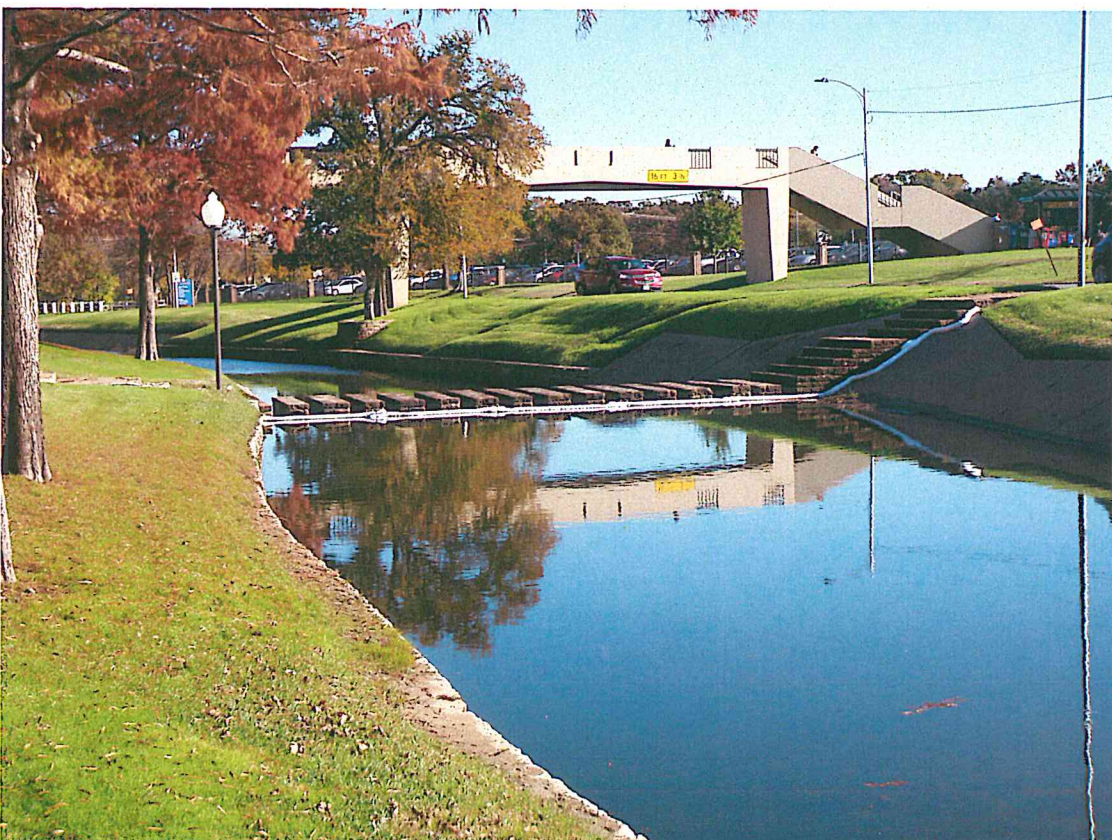
Photograph: 12

Absorbent boom placed in Timer Brook east of Cooper Street to catch sheen.

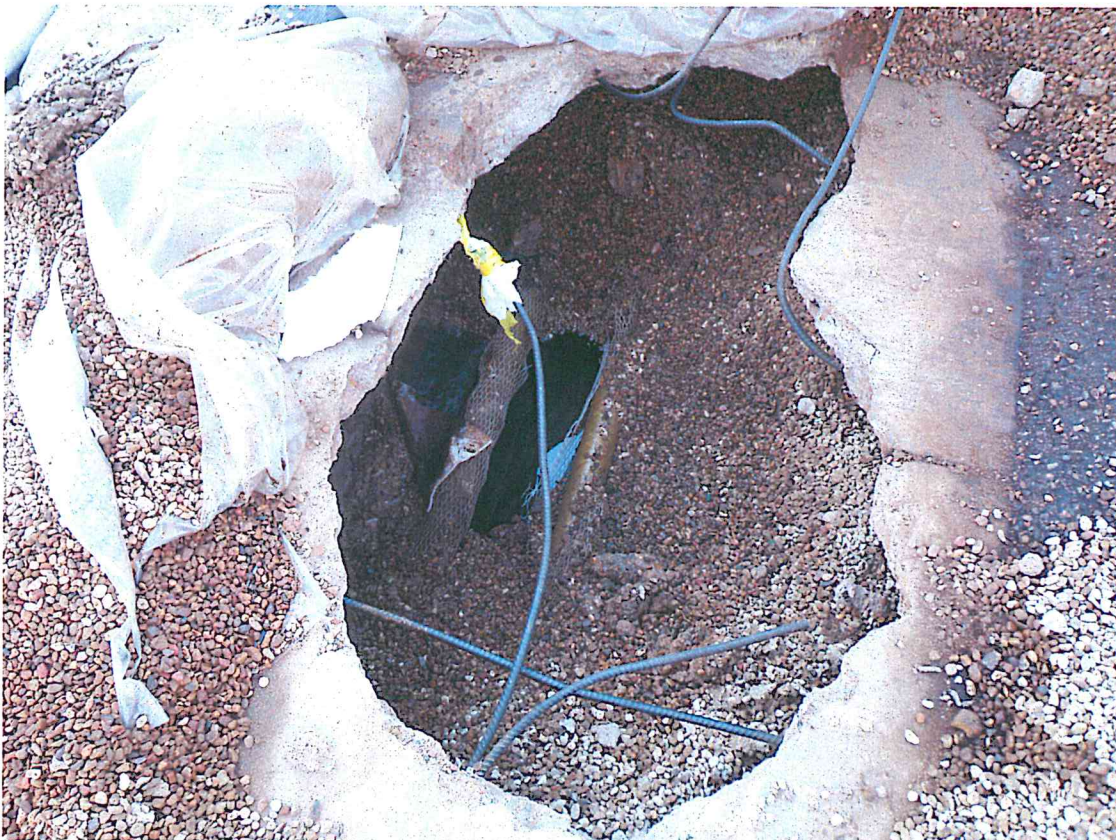
Photograph: 14

Fuel in the pipechase pea gravel backfill material greatly reduced by removal via vacuum truck.

The diesel and gasoline product lines are visible in this picture.

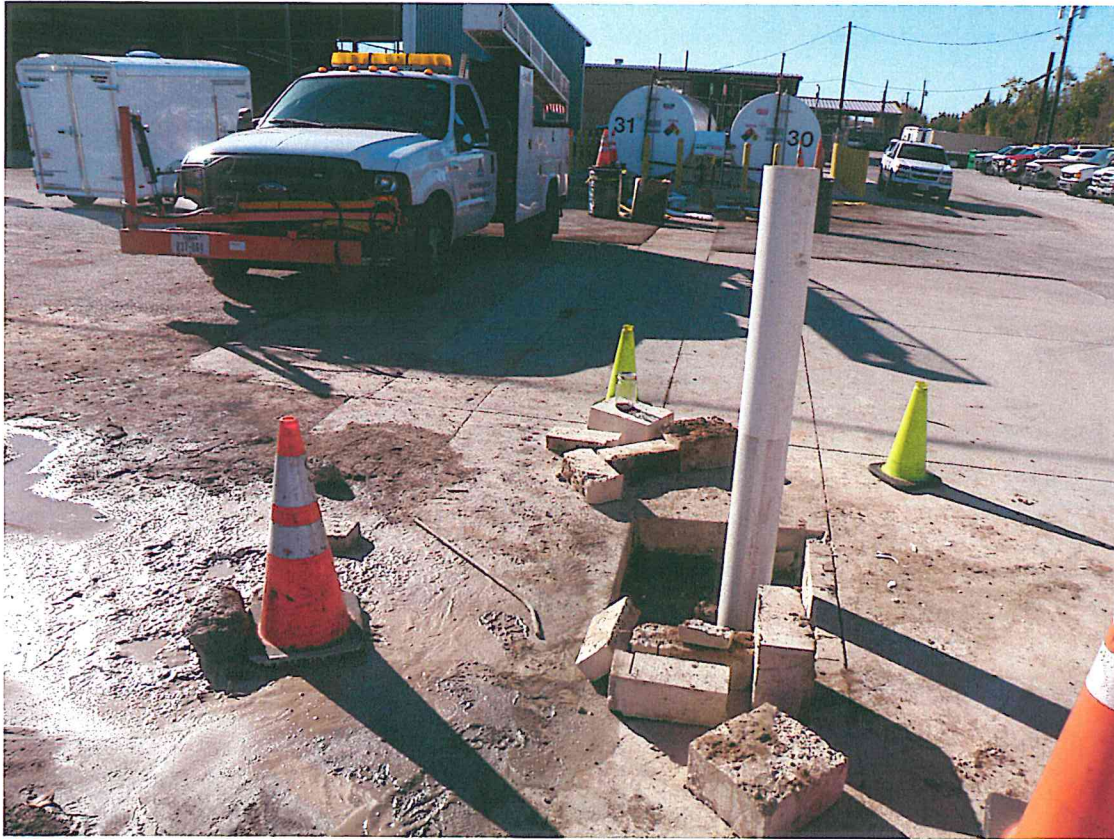
Photograph: 15

Recovery wells were installed as directed by TCEQ in the pipechase and the former UST tank field (pictured here).

The pipechase runs adjacent to the former UST system and diesel product was found to have entered the former tank field since it intersects the pipechase.

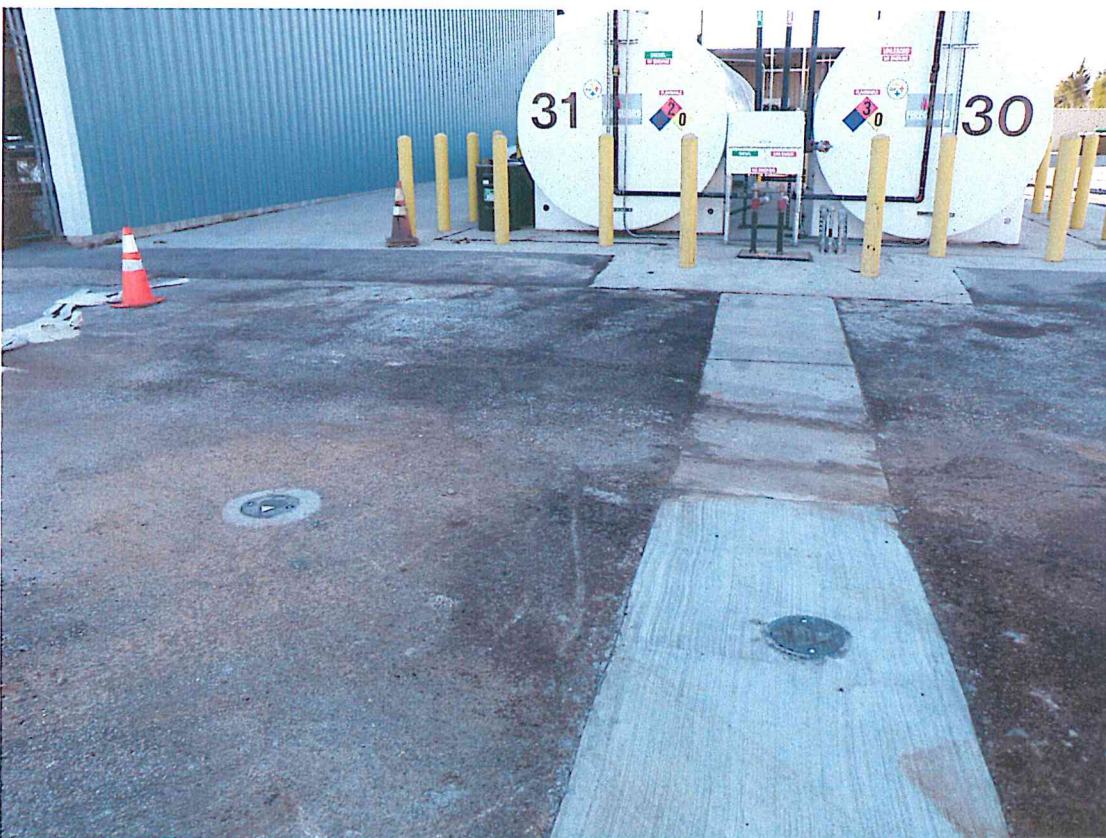
Photograph: 16

View of the completed recovery well in the pipechase.

In addition, four monitoring wells have been installed to help delineate the potential migration of the fuel in the subsurface (one of the monitoring wells is also pictured here).

December 8, 2015, a site check by Lonnie Gilley found Consolidated Consulting Group was installing four additional monitoring wells in the vicinity of the release to delineate the extent of any subsurface migration. Free product thickness in the recovery wells down to 1 to 2 inches. Impact to tributary has intermittent sheen as it slowly releases from impacted soils along the banks. A couple of areas with cattails were noted by the Cleaning Guys that were making cleanup in those areas difficult. TCEQ concurs with city to chop cattails below the water line to aid in remediation efforts. Also approved soil sampling at designated areas along the banks to aid in determining depth of saturation to gauge how long leaching may occur and seeding the areas with Winter Rye to aid in biodegradation.
